# EVALUATION OF EXISTING CONDITIONS

# FORT RIVER ELEMENTARY SCHOOL

**Address:** 70 South East Street  
Amherst, MA 01002

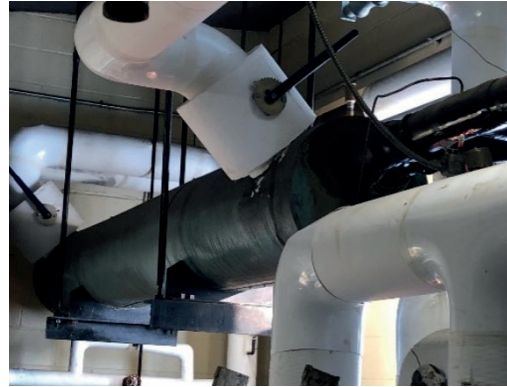
L - original 49 year old air cooled condensing unit on roof failed last year. C - note temporary electrical power cables on roof which were ran from the chiller to the rental chiller; nameplate was illegible, but thought to be 70-tons, which would be considered severely undersized by today's standard. R - chiller barrel (black above white pipes) inside right below.

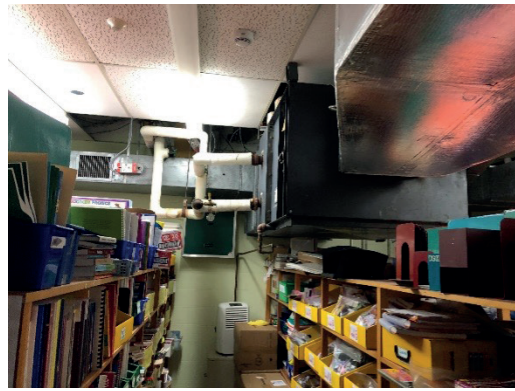
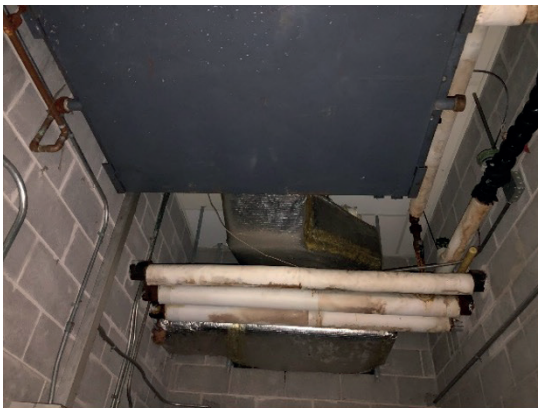
Another original vintage indoor AHU, showing rust perforations along the cooling coil section.

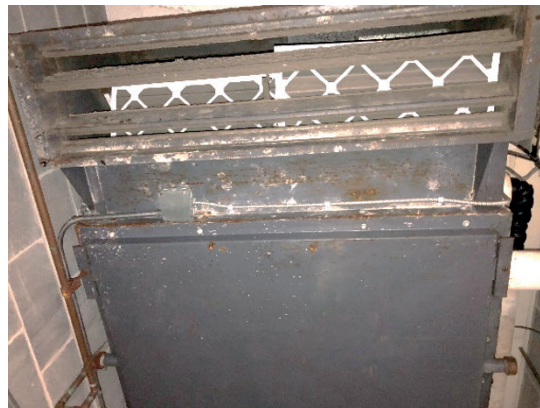
Potentially encapsuated ACM pipe insulation.

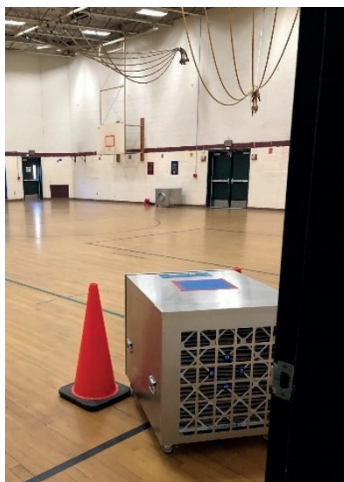
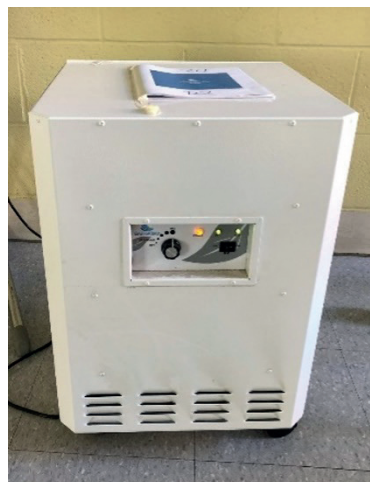
L- large portable HEPA filter unit in Gym. C & R- smaller and quieter EnviroKlenz portable HEPA filter/ UVC light units were found throughout the school.

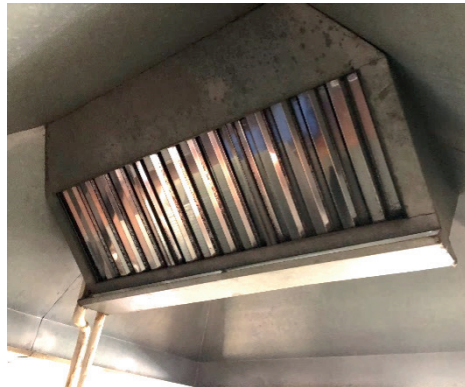
L & C- kitchen cooking line exhaust hood; the filters are Code- compliant panel type, but does not have Code mandated Ansul system. R- make up air is untreated (filtered or heated) through intake louver... understandably during summer it is hot and humid, but during winter the kitchen becomes freezing cold.

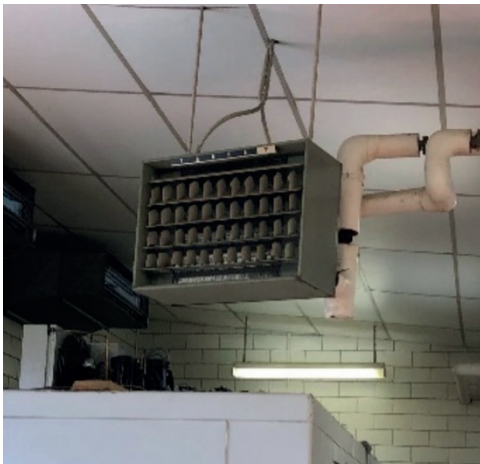
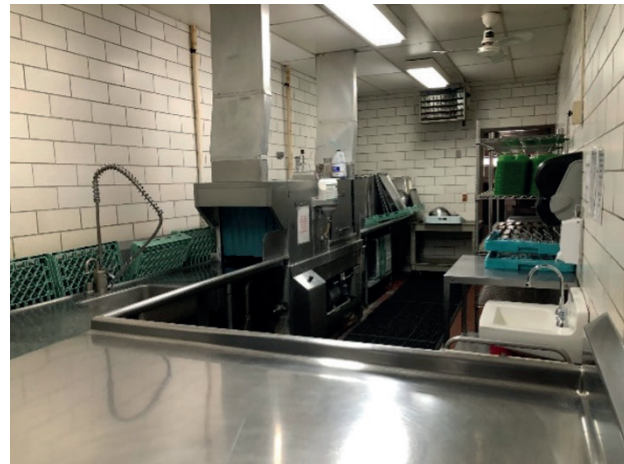
L - only means of heat in the kitchen is this hot water unit heater. R - dishwasher, and exhaust ducts up.

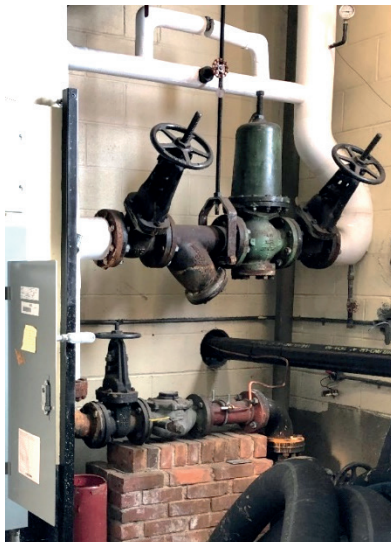
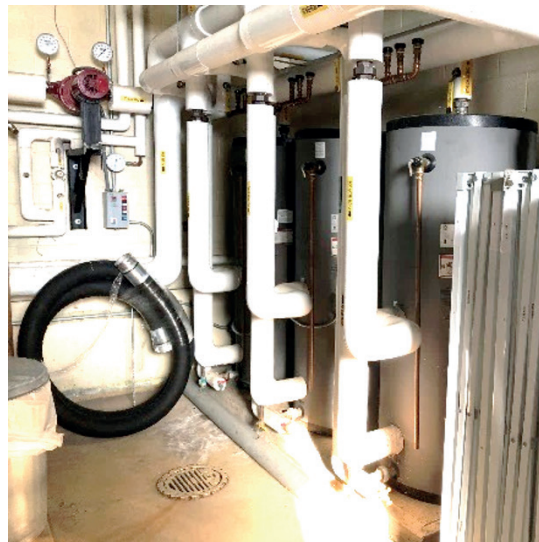
1. System is original 1973 vintage.
2. Potable water is connected to the municipal system but does not have Code mandated backflow preventor.
3. Sanitary drain system is connected to the municipal system.
4. Fixtures have been repaired/ replaced as they have failed.
5. Indirect domestic hot water heater (boiler has to operate year-round just for this!).

L - Water service comprising of water meter and pressure regulator, suggesting that they have more than 80 psig feed. Note that there is no Code mandated backflow preventor. R - indirect domestic hot water heaters.

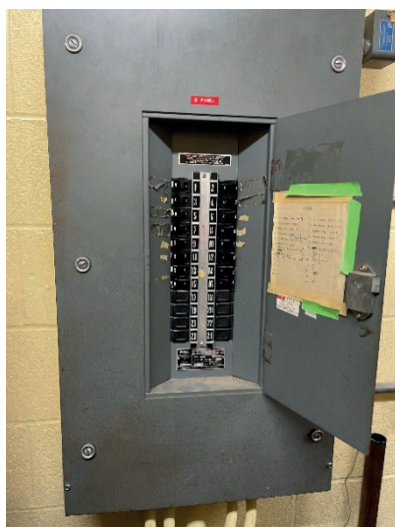
HVAC Panel

During our walk-through of the building, it appeared to us that the Federal Pacific panelboards and associated feeders have not been upgraded or replaced. We did notice that a newer panelboard was installed to serve selected new loads.

Based on life expectancy and Federal Pacific, the panelboards would be rated to be in poor condition.

Federal Pacific has been out of the switchboard and panelboard business for over thirty-five years. Federal Pacific equipment is notorious for very poor quality and high failure rates. The electric service equipment is past its life expectancy, is in poor condition and needs to be replaced.

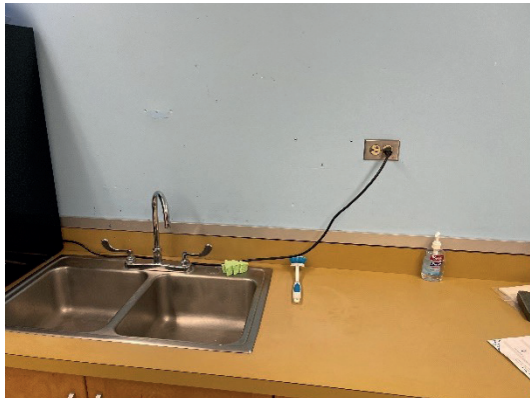
There are a limited number of receptacles in all spaces including classrooms and offices. Originally, there was two to three receptacles in each classroom and observed two receptacles in many classrooms. The receptacles are of the grounded type.

Receptacles in surface mounted raceways have been added in classrooms and other spaces to meet increased power needs for technology, however the quantity of receptacles is insufficient for current classroom and office requirements.

Non GFCI Receptacle at Sink

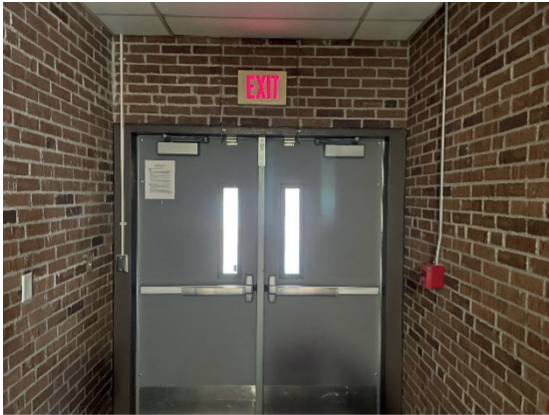
Exit Sign

There appears to be exit signs in all paths of egress. There are several different generations of exit signs in the building. Not all exit signs are internally illuminated. Overall exit signs conditions are fair.

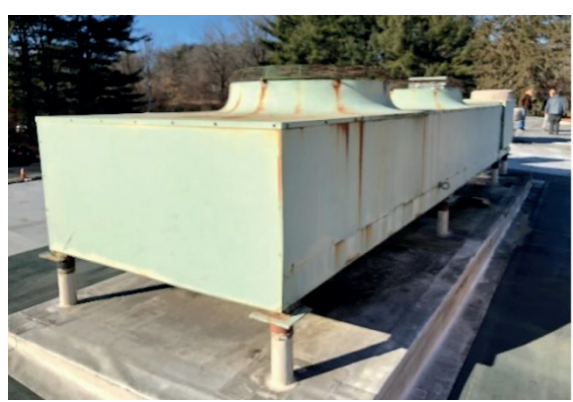
L- original 52 year old air cooled condensing unit on roof, still works most times; nameplate was illegible, but thought to be 70-tons, which would be considered severely undersized by today's standard. R- chiller barrel (black above white pipes) inside right below.

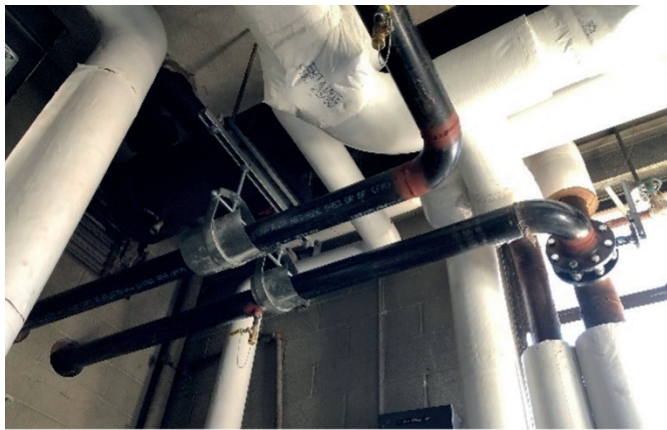
L- A set of 4" lines are extended to outside for temporary chiller hookup in case of chiller failure. R- boiler combustion air duct; lower opening had to be blocked off to prevent freezing.

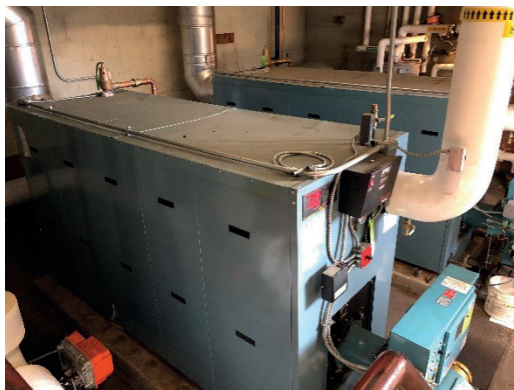
L- two cast iron oil fired boilers. C- Breechings with draft damper ties into existing masonry chimney. R- chimney and chiney cap on roof.

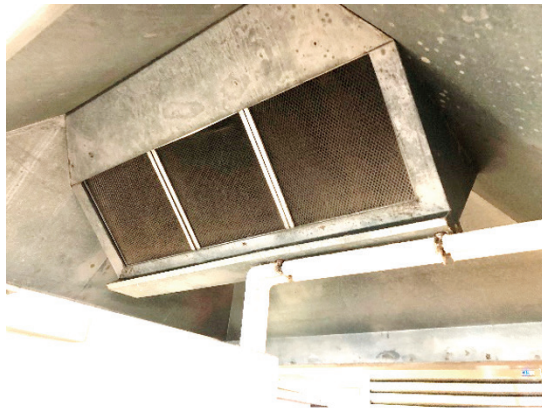
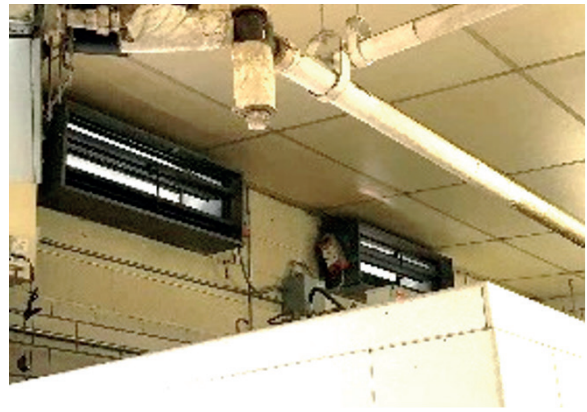
L - kitchen cooking line exhaust hood; the filters are non-Code-compliant mesh type, and does not have Code mandated Ansul system. R - make up air is untreated (filtered or heated) through intake louver... understandably during summer it is hot and humid, but during winter the kitchen becomes freezing cold.

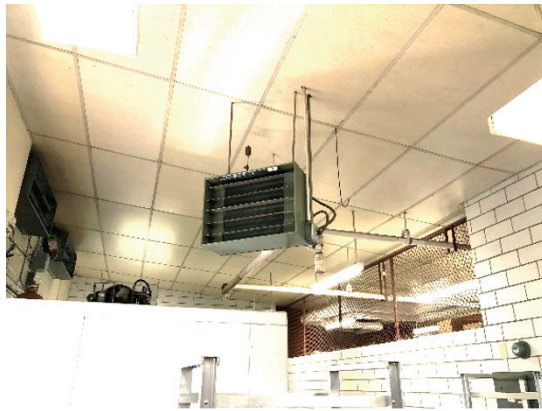
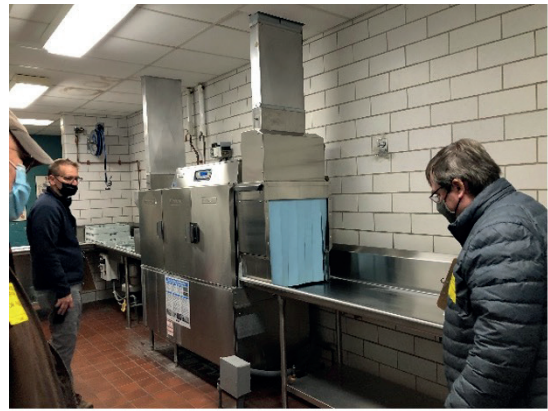
L - only means of heat in the kitchen is this hot water unit heater. R - dishwasher, and exhaust ducts up.

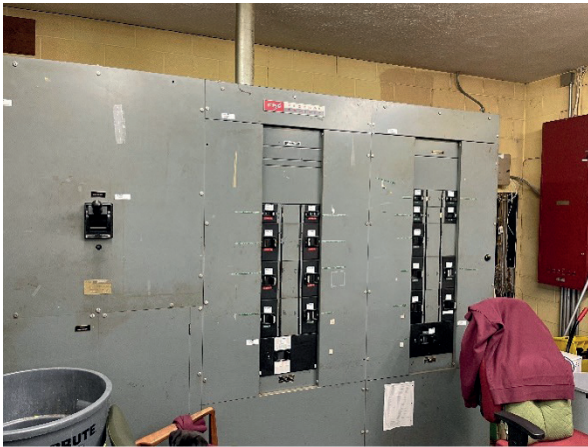
Despite being maintained by the owner; the switchboard would be rated in poor condition, due to age and being manufactured by Federal Pacific.

During our walk-through of the building, it appeared to us that the Federal Pacific panelboards and associated feeders have not been upgraded or replaced. We did notice that a newer panelboard was installed to serve selected new loads.

There does not appear to be any spare capacity or breakers in most 208V panels for additional receptacles.

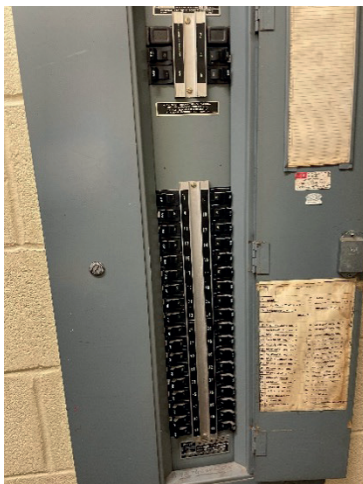
Split Bus Panel

Federal Pacific has been out of the switchboard and panelboard business for over thirty-five years. Federal Pacific equipment is notorious for very poor quality and high failure rates. The electric service equipment is past its life expectancy, is in poor condition and needs to be replaced.

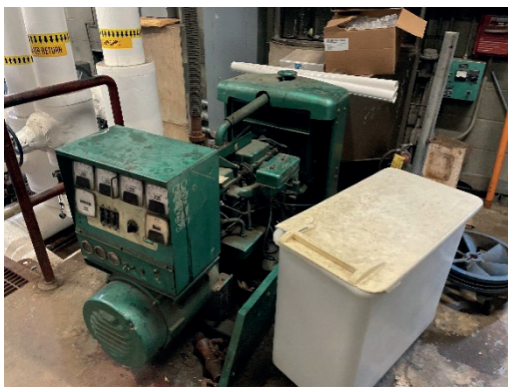
Generator

The emergency electric service including generator, and automatic transfer switch are in poor condition. The generator and associated panels are almost 50 years old and well past its life expectancy, do not meet current life safety codes, and need to be replaced.

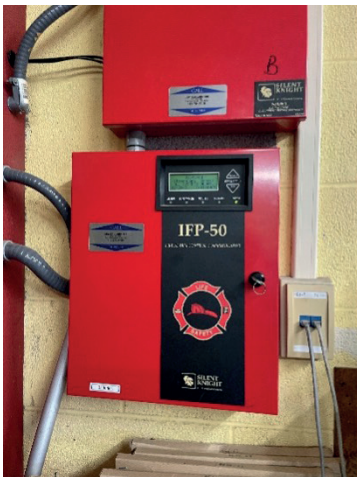
Control Panel

The fire alarm system is in poor to failing condition, well past its life expectancy and needs to be replaced.

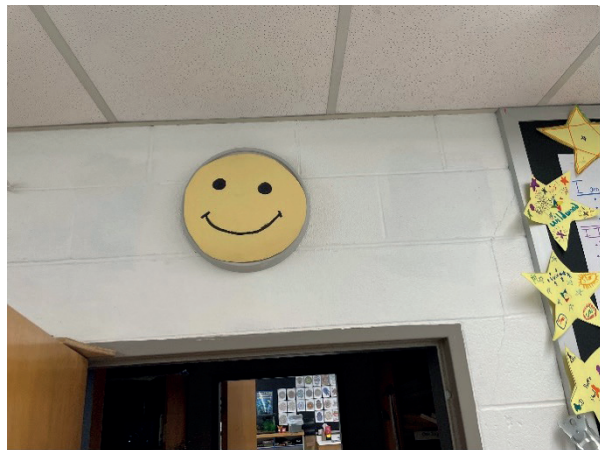
Happy but Failed Clock

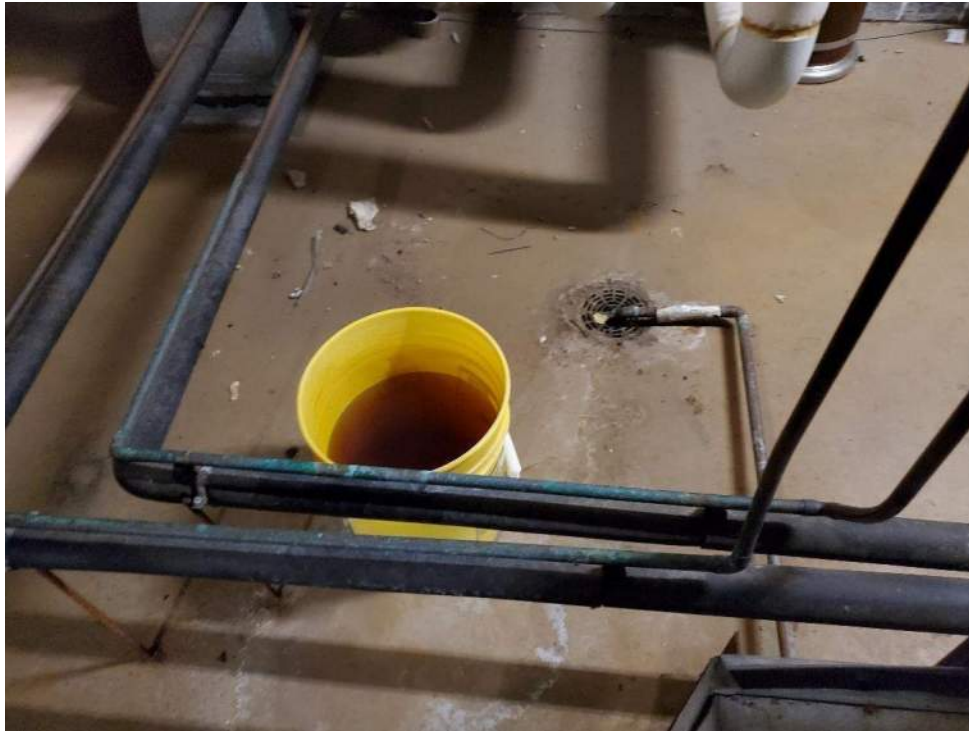
**Photograph 21** – Mezzanine surface drain and 5-gallon bucket 2/3 full of leaking water.

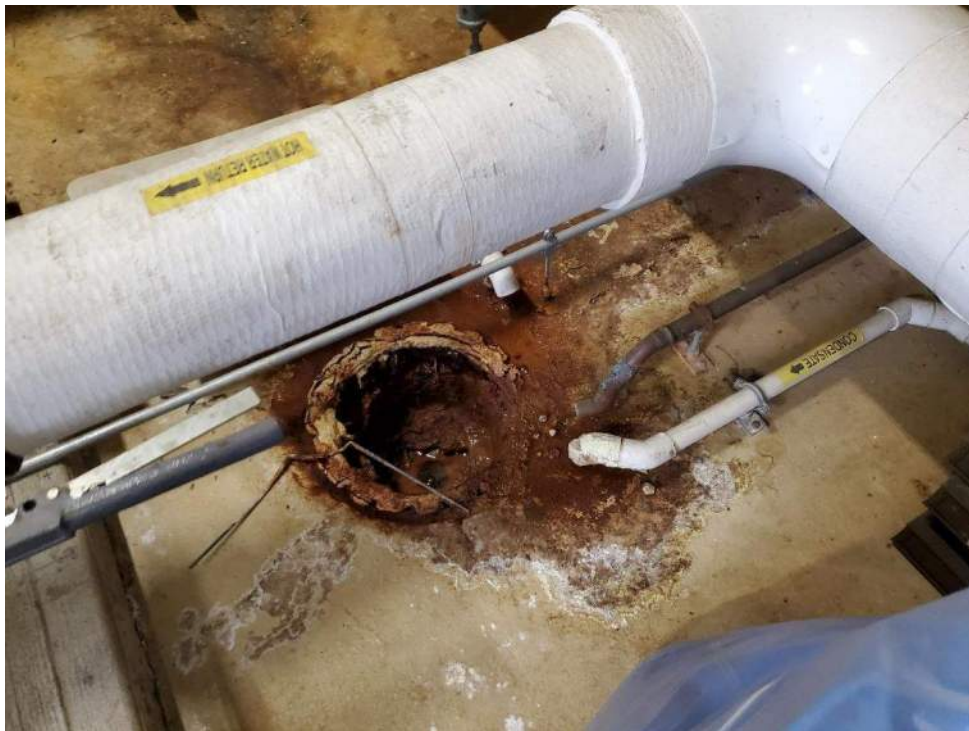
**Photograph 30** – Mechanical room drainage with some corrosion.

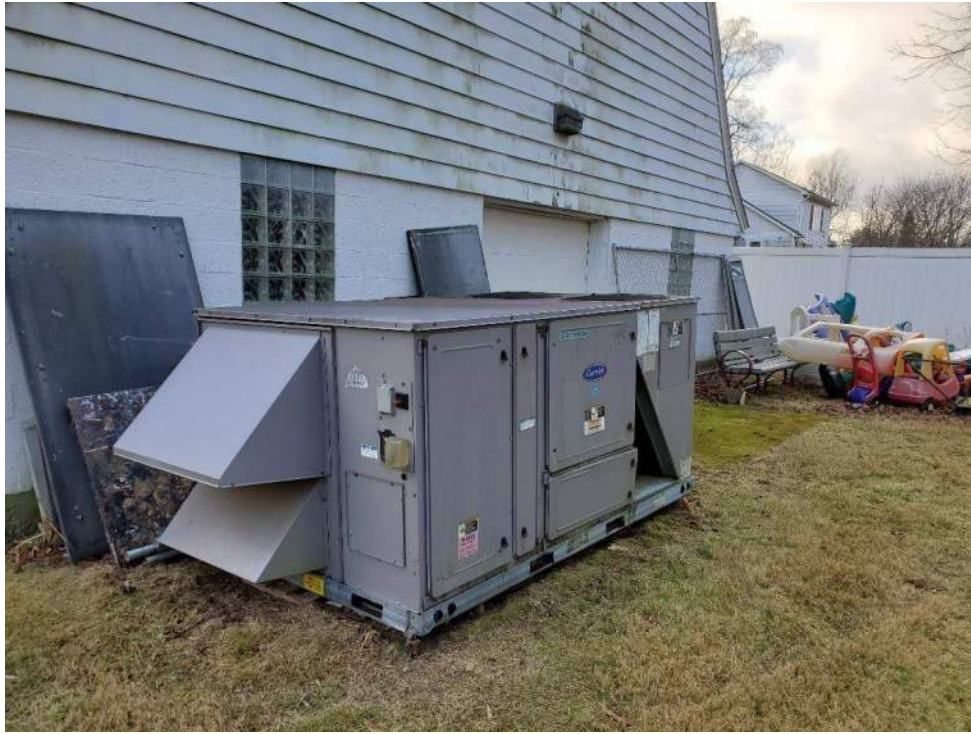
**Photograph 35** – Air conditioning unit, no longer in use.
